Sieve Structures to Control Gully Erosion on the Borana Plateau, Ethiopia

RB-24-2015

August 2015

Research Brief

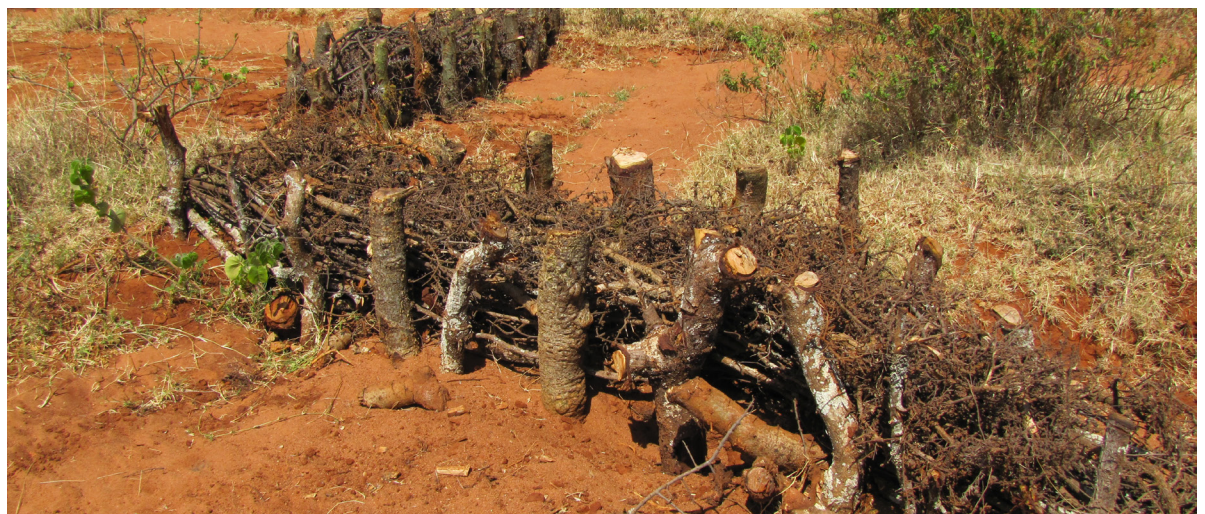
A pair of sieve structures at the confluence of 2 secondary gullies in the Dikale enclosure. The basic design consists of two rows of tree stumps sunk into the gully floor and packed with acacia branches. Some excavation has occurred in sand at the base of the sieve near the camera due to animal activity. (Photo credit: Brien E. Norton).

The soil and water conservation team at OARI experimented with different designs of sieve structures. The initial efforts in March-April 2014 comprised a single row of posts, often incorporating aloe sprigs, across shallow depressions. They were effective in reducing water flow and trapping sediment as long as the margins extended across the entire gully depression. The second generation of sieve structures installed in October 2014 comprised two rows of posts 25-50 cm apart. The space between the rows was packed horizontally with *Acacia*

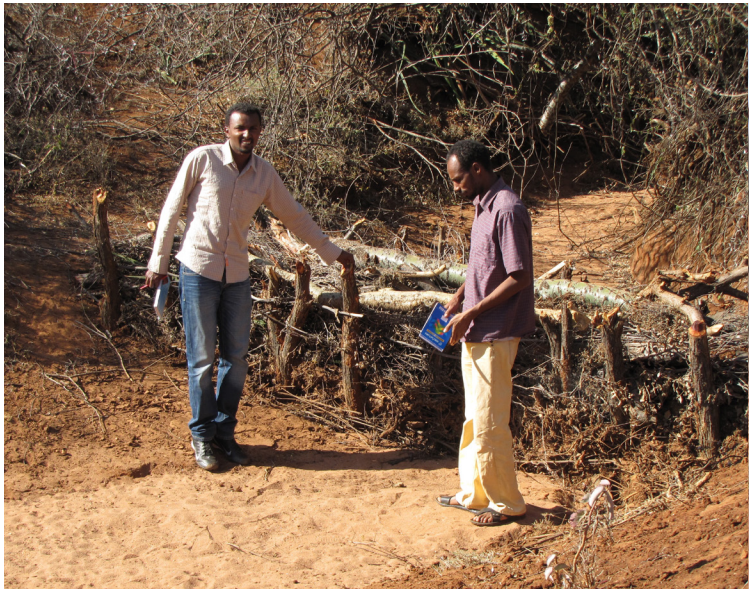
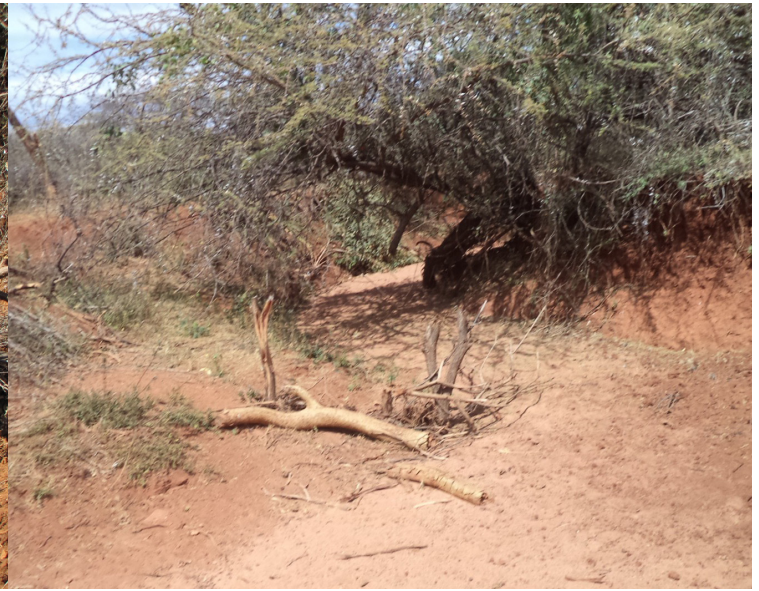
A pair of photos showing (left) an intact sieve structure and (right) the same structure destroyed by flooding in the heavy spring rains. All the branch packing, the large ballast logs, and most of the upright stubs have been washed away in the right photograph. (Photo credits: (left) Brien E. Norton and (right) Bedasa Eba).

Data were collected on the gully length between consecutive sieve structures, the mean width of the gully and depth of sediment. The intent was to compare the volume of sediment in a gully section before and after a rainy season. However, the failure of these three sieves in the long rains of April-May 2015 annulled the exercise.

In June 2015 following the long rainy season, the OARI team surveyed the sieve structures previously monitored. In general, the sieves in the relatively short secondary gully had maintained their structure, serving to slow gully flows and capture sediment. Sieves that had received a low score of 1.5 were ineffective in stopping erosion around the exposed edges. The three sieves in the deep part of the main gully all failed. The packing branches had washed away and only some of the upright stubs remained. The same failure of sieve structures had occurred in the main gully leading into the Harweyu pond.

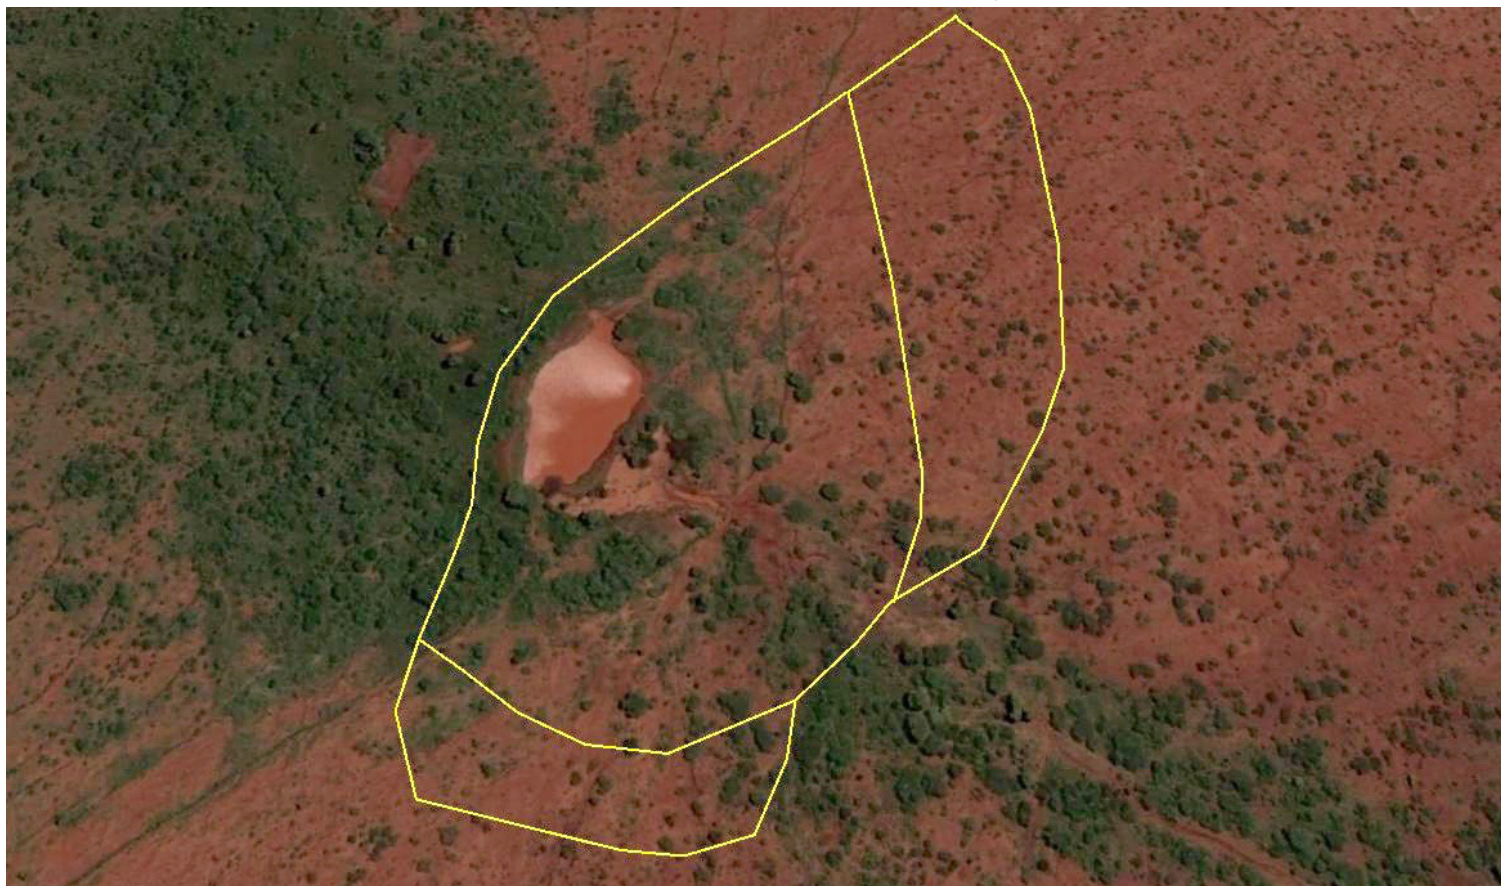
A Google Earth image showing the original fence outline at Dikale and the two extensions to the enclosure. Note the main gully running into the pond from the south-east, and a pair of secondary gullies that flow north, converge and join the main gully close to the pond. The main gully runs straight into the pond from a catchment of 0.5 km² and is the principal source of both water and sediment. (Image compiled by Brien E. Norton)

Only that portion of the gully within the enclosure was addressed, leaving 500-600m of upstream gully untreated. The length of this main gully outside the enclosure fence was served by several secondary gullies and drained a catchment of around 0.5 km². It is the principal source of both water and sediment feeding the Dikale pond.

In order to rehabilitate a gully-infested landscape, a comprehensive approach should be taken. The failure of sieve structures across the main gully in the Dikale enclosure inadvertently demonstrated the importance of beginning gully remediation at the gully head. Control of head cutting must come first, otherwise erosion will continue to cut back upslope. None of the sieve structures installed in lower reaches of a large gully can stop the onslaught of floodwater rushing into the porous barriers and destroying them. Full-scale gully remediation should be applied to the secondary gullies as well as the main gully in the Dikale pond catchment.
